Legionella Risk Assessment

61
Howe St
Derby
DE22 3ES

Assessor name: Mrs. Zoe Cashmore
Reference: 001071
Assessment date: 08/09/2025
Property type: House

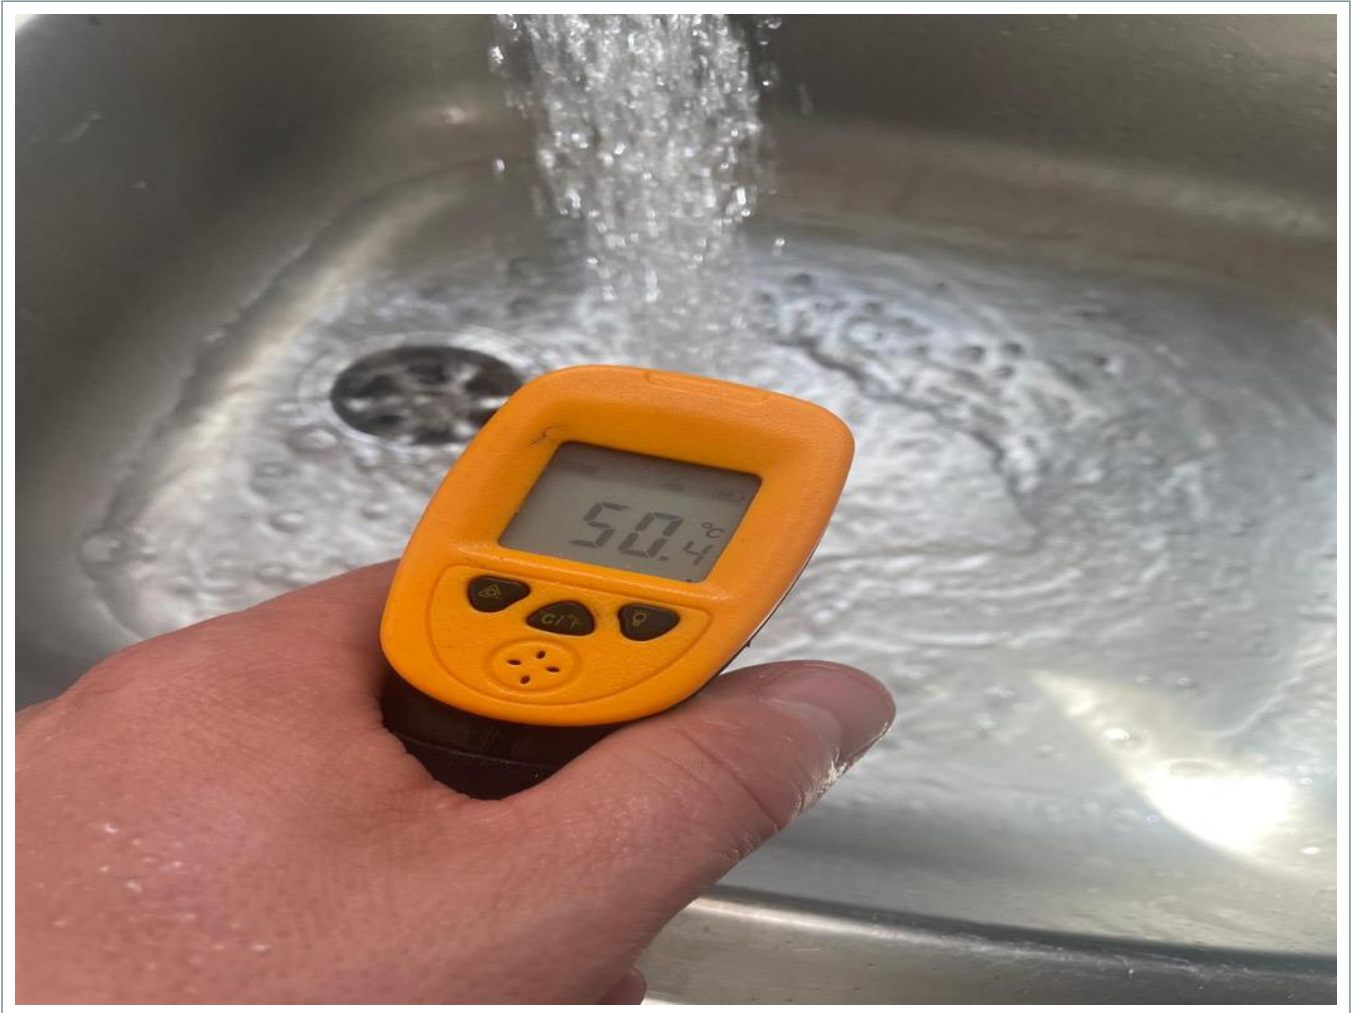
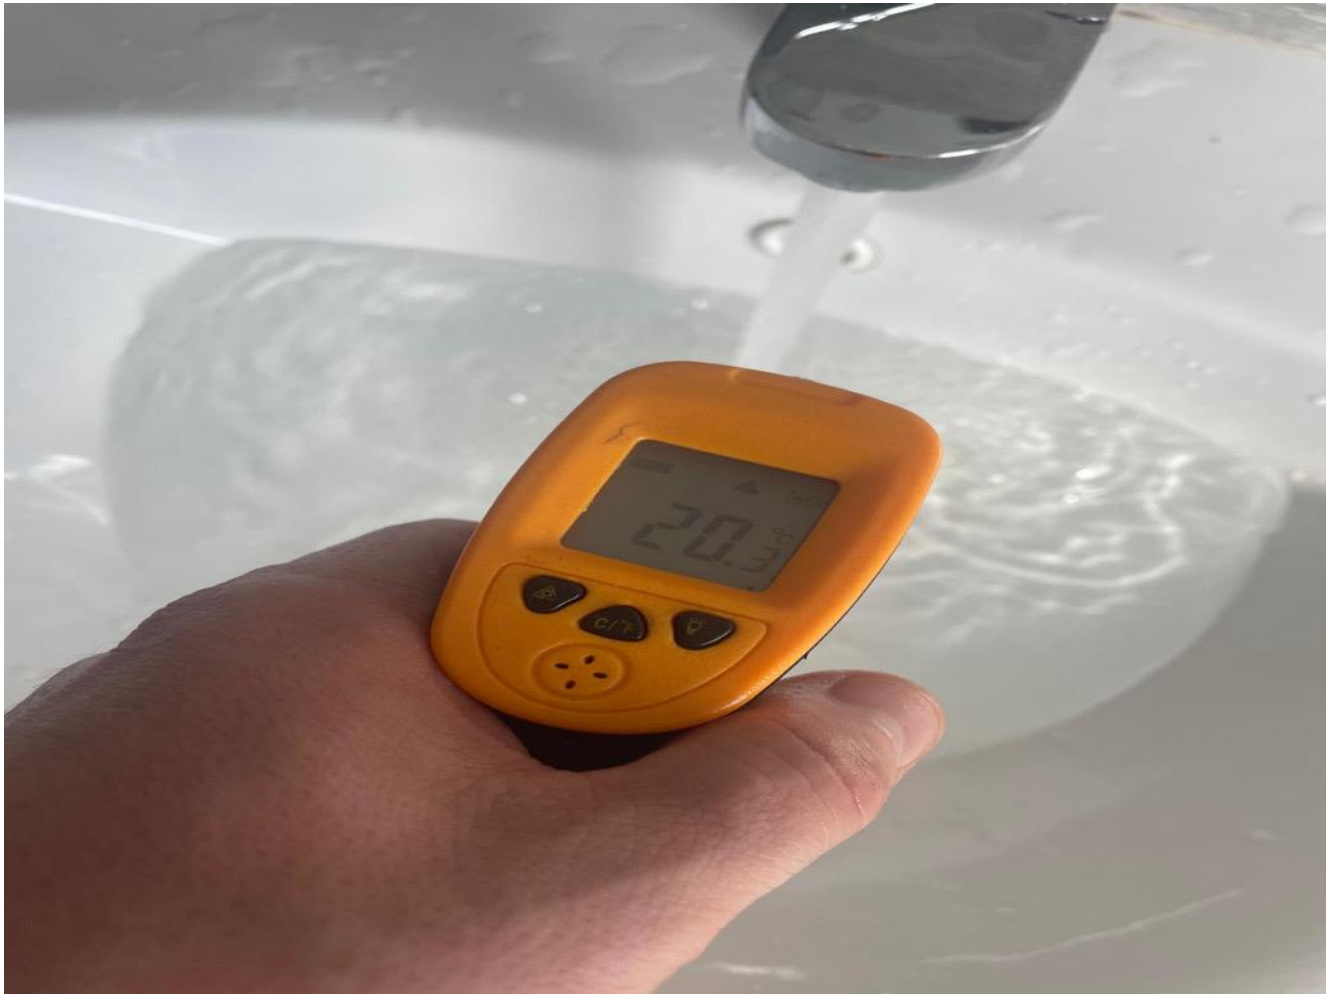
1. Water temperature at outlets
<p>Is cold water temperature below 20°C? Yes</p> <p>Highest recorded temperature (°C) 50</p> <p>Is hot water temperature above 50°C at outlets? Yes</p> <p>Lowest recorded temperature(°C) 20</p> <p>Are TMV's present? Unknown</p> <p>Is hot water temperature from TMVs (if fitted) 39-43°C at outlet(s)? N/A</p>
Issue(s) identified/comments
N/A
Risk rating
Risk level 2 - Low
Recommendation(s)
N/A
Photo of water outlet

Ensure boiler/water heater is set to 60°C so that water reaches outlets at above 50°C. Ensure cold water does not exceed 20°C by making sure pipes and storage tanks are insulated. Ensure water temperature at outlets is 39-43°C where TMVs are fitted, or above 50°C at the hot pipe feeding the TMV if it is accessible. TMVs should be tested at least annually.

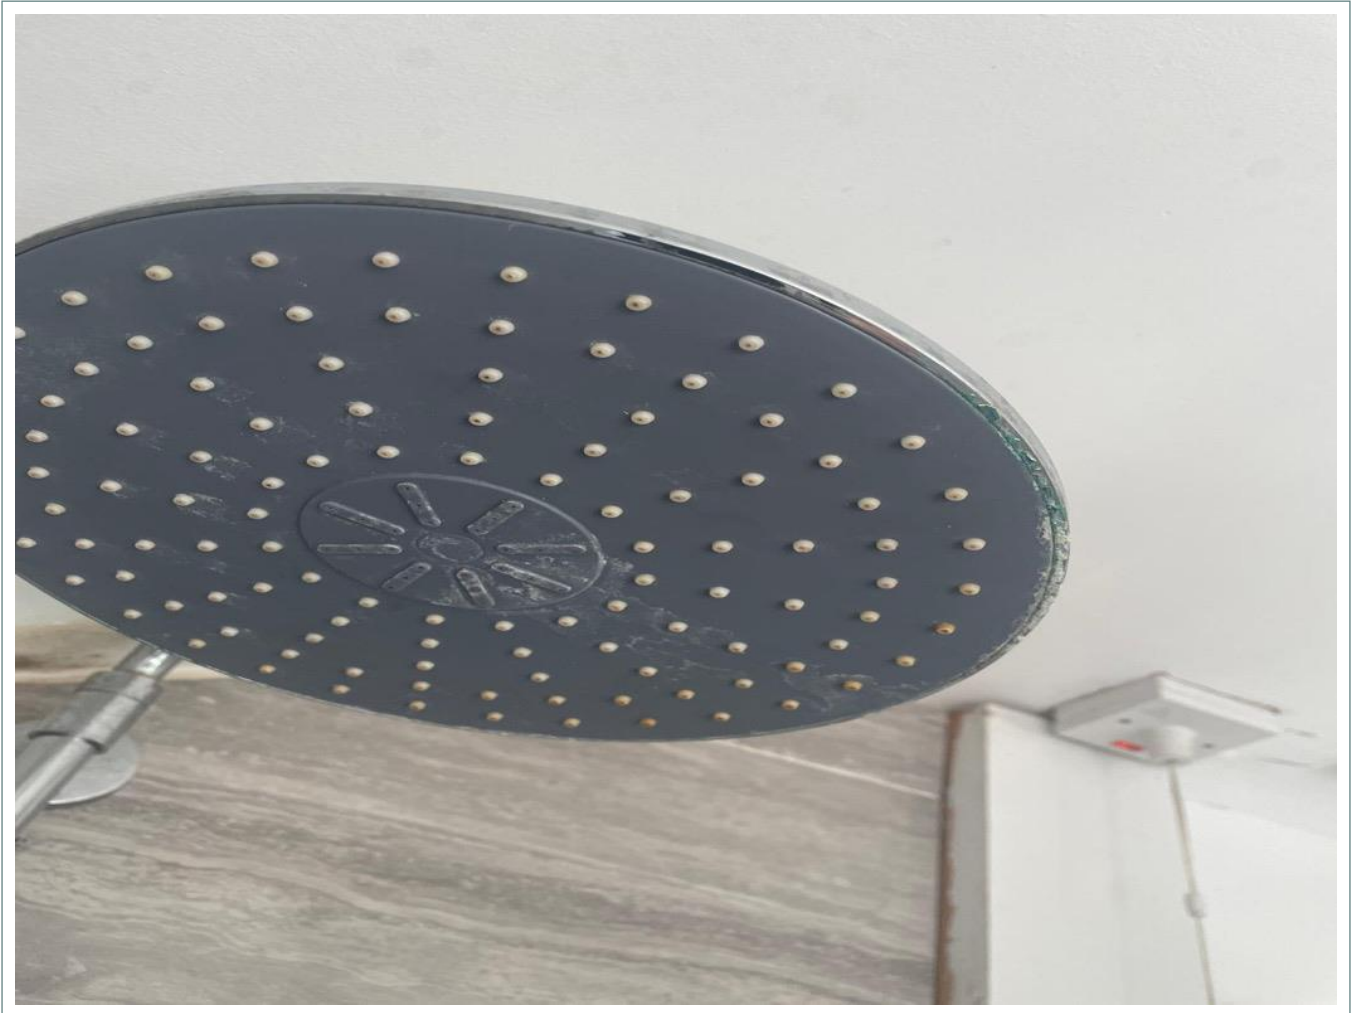
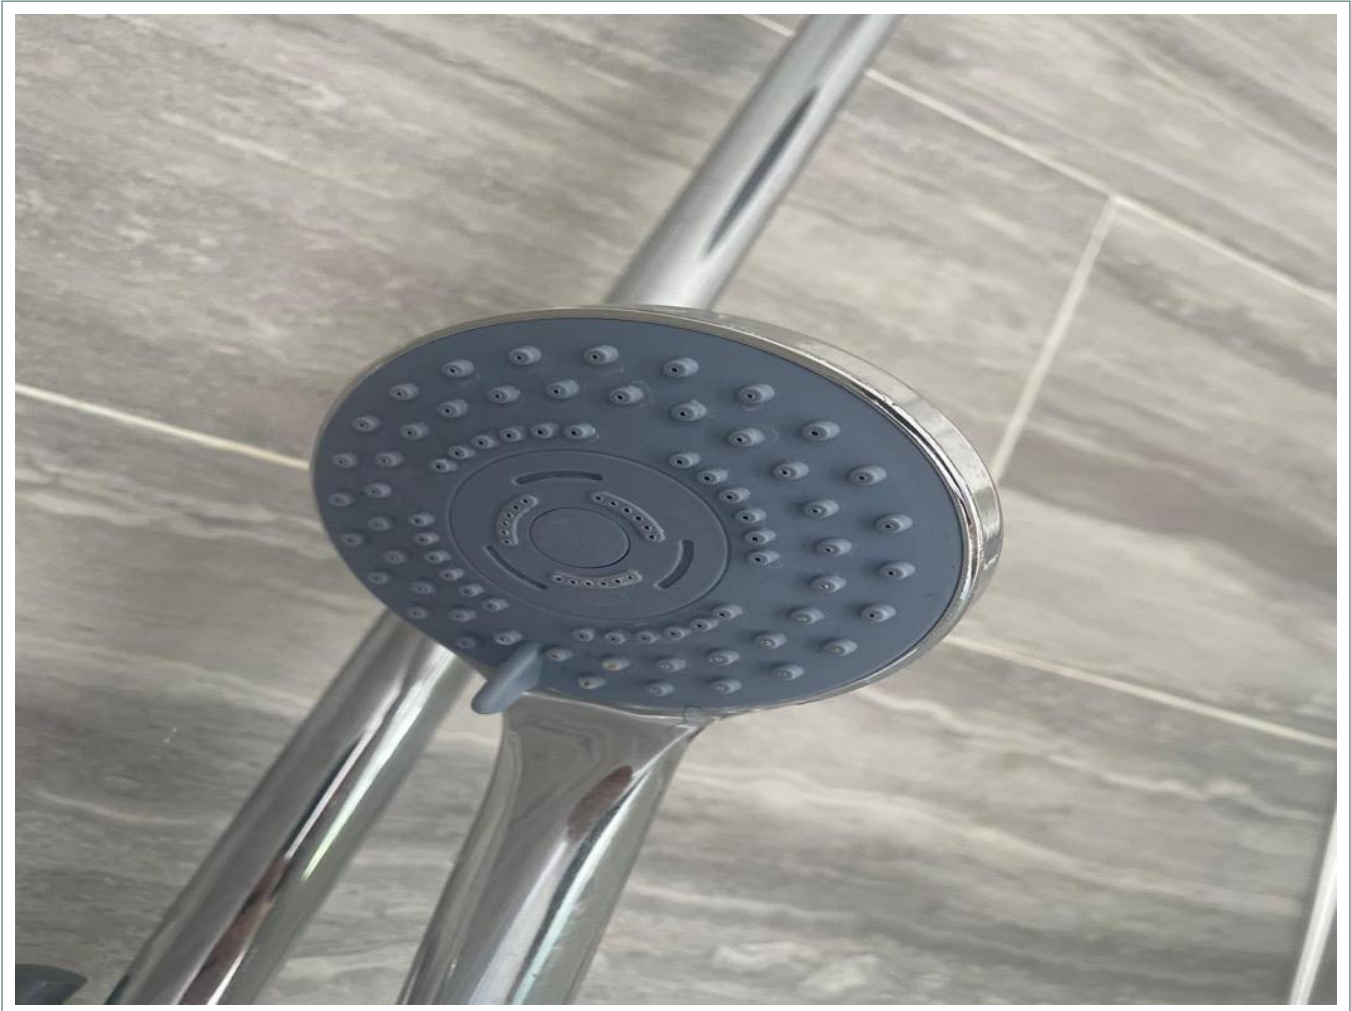
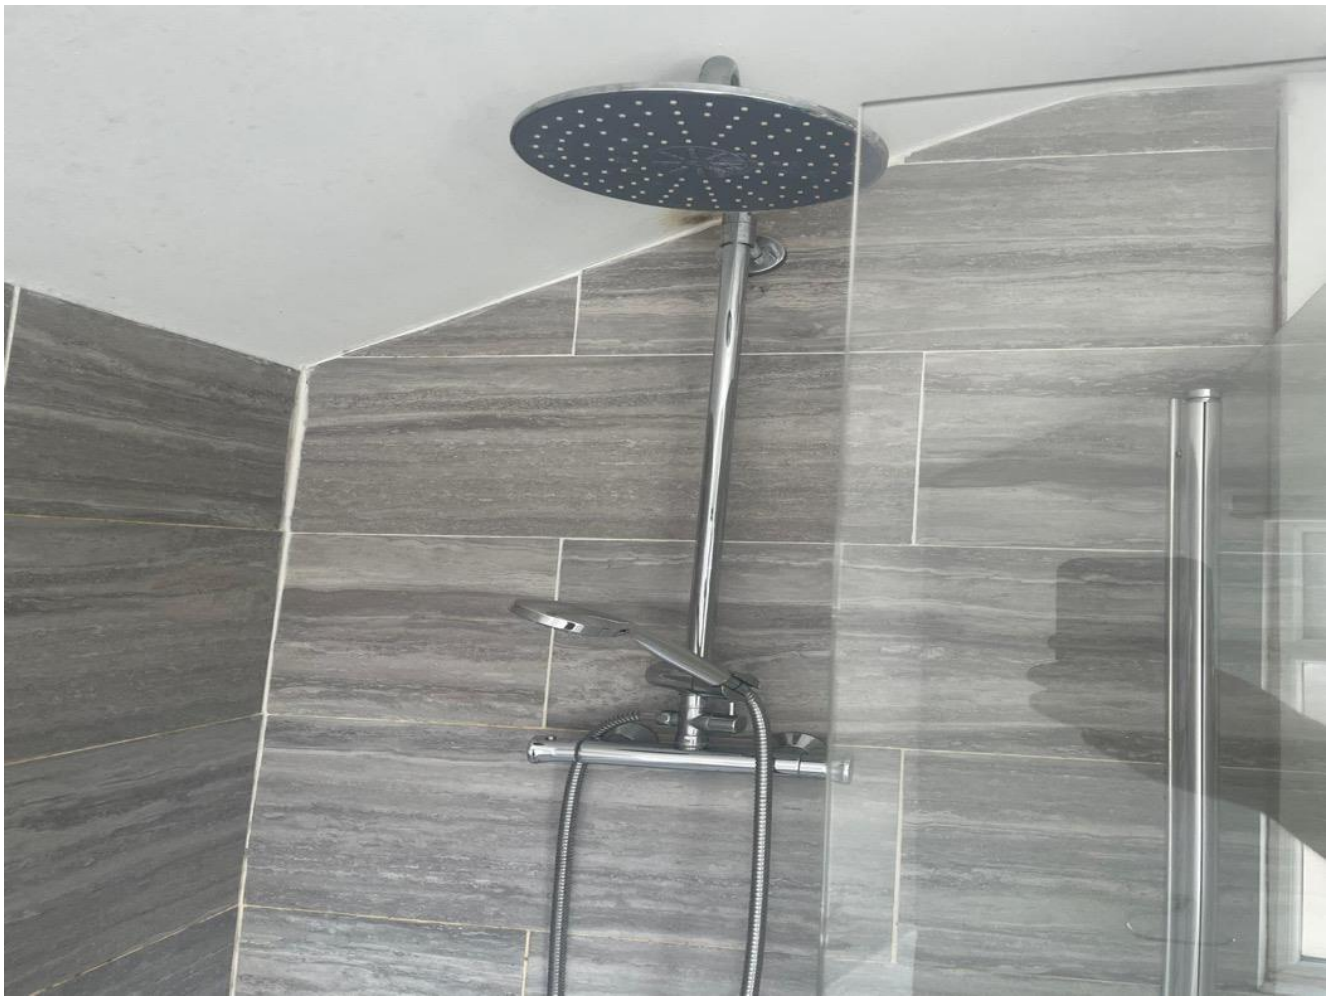
5. Shower heads, taps and other spray outlets
Are there any showers present? Yes Are there any spray taps present? No Is there a hose pipe present? No
Issue(s) identified/comments
N/A
Risk rating
Risk level 2 - Low
Recommendation(s)
N/A
Photo of Shower heads, taps and other spray outlets

Any showers/spray/taps/hose pipes should be flushed through weekly. Shower heads and other outlets should be de-scaled at least every 3-6 months. Consideration should be given to replacing spray taps with normal taps.
